### QUALIFIED PROFESSIONAL CHECKLIST FOR FORESHORE DEVELOPMENTS

Property: 12892 Pixton Road, Lake Country, BC

Attachment E-DVP00377-QP

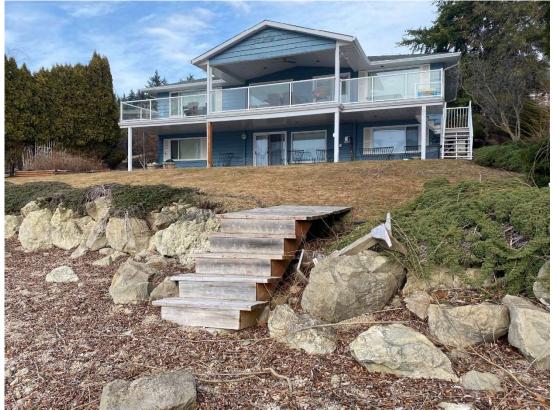
document environmental values associated with the site? If yes, list these values. A field assessment is expected in most cases.  March 5, 2021 of 12892 Pixton Road, Lake Country, BC. The subject property has an existing single-family dwelling (Photo 1). The private moorage adjacent the subject property that was present in the 2018-2019 orthophotos has been removed; however, a boat			the FIM was 25 docks per km, with retaining walls over 40% of the 439.7 m shore segment length. Juvenile rearing value was noted to be moderate. The Aquatic Habitat Index (AHI) rating is currently moderate, with an AHI potential of moderate. The rare
(Photo 2).	document environmental values associated with the site? If yes, list these values. A field assessment is	Yes	March 5, 2021 of 12892 Pixton Road, Lake Country, BC. The subject property has an existing single-family dwelling (Photo 1). The private moorage adjacent the subject property that was present in the 2018-2019 orthophotos has been removed; however, a boat lift remains along the foreshore

Photo 1: Looking towards the subject property and the existing single-family dwelling (March 5, 2021).

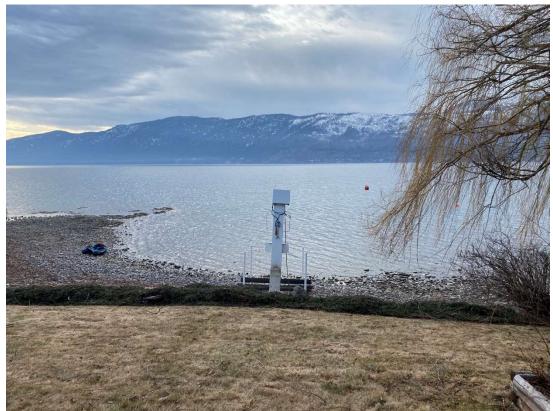
Photo 2: Looking southwest towards Okanagan Lake and the boat lift remaining along the foreshore (March 5, 2021).

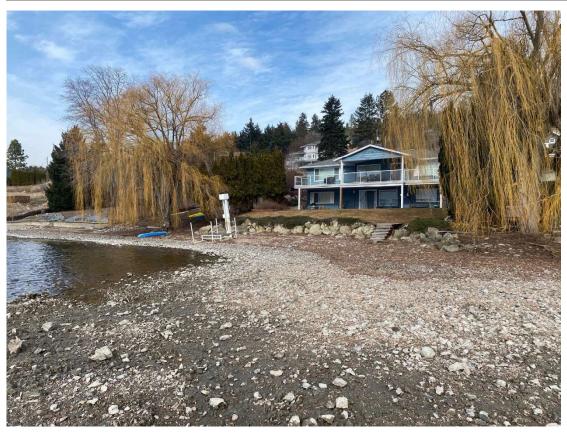
Foreshore and riparian modifications include a staircase providing foreshore access, formal landscaping throughout the riparian area, and a riprap retaining wall along the subject property (Photos 3 and 4).  The riparian area has been modified with formal landscaping,
		including turf and horticultural shrub species such as juniper and cedar. Mature willows occur along the property boundaries and appear to be situated on the neighbouring properties.
		Beach substrates consist primarily of gravel and cobble along the subject property, with sporadic boulders associated with retaining (Photo 5). A significant bedrock formation occurs along the property, largely towards the southern property boundary and beyond (Photos 6 and 7). The bedrock shoal extends as much as 41 m from the approximate high water level at the southern property corner (Photo 8).
		The proposed moorage is situated to the north of the majority of the bedrock; however, another patch of bedrock is visible to the north of the moorage location.

Photo 3: Looking towards the subject property and existing riparian condition; the mature willows occur on the adjacent properties (March 5, 2021).

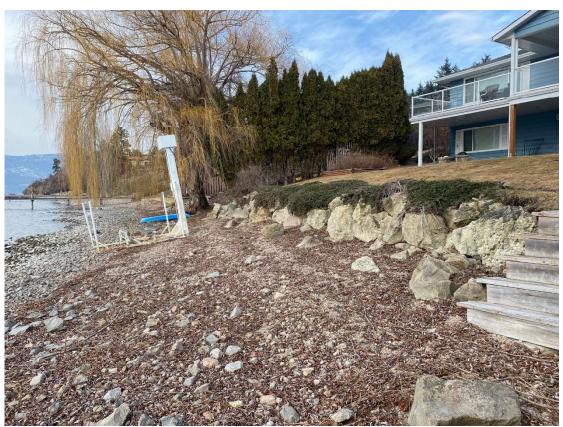
Photo 4: Looking northwest along the foreshore towards the boat lift remaining from the previous moorage, rock retaining wall, and riparian condition (March 5, 2021).

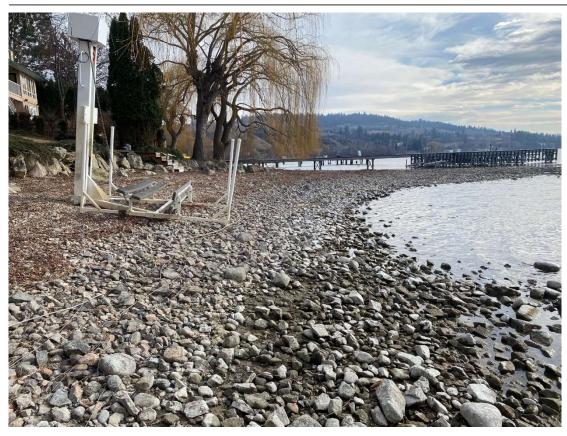
Photo 5: Looking southeast along the foreshore of the subject property over predominantly gravel and cobble beach substrates (March 5, 2021).

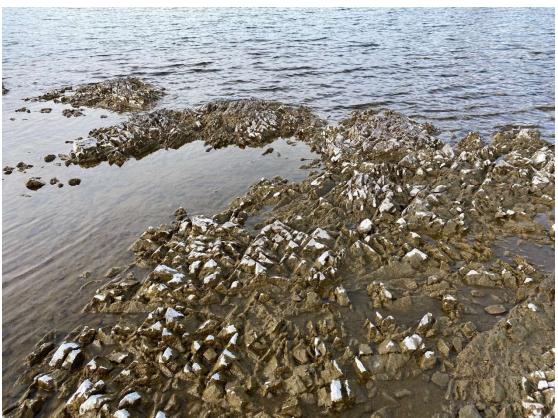
Photo 6:
Looking
towards
bedrock
substrates
along the
subject
property to the
south of the
proposed
moorage
location
(March 5,
2021).

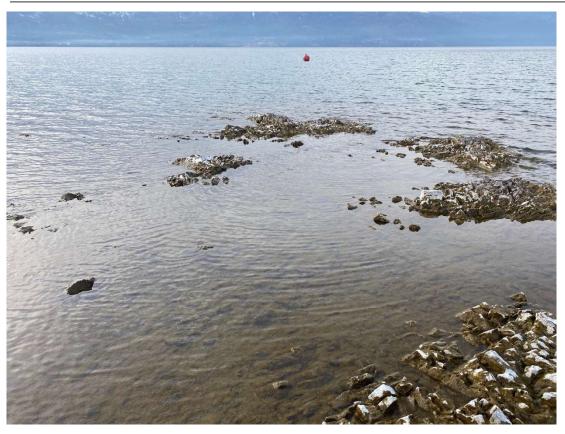
Photo 7: Looking southwest towards Okanagan Lake and the bedrock substrates (March 5, 2021).

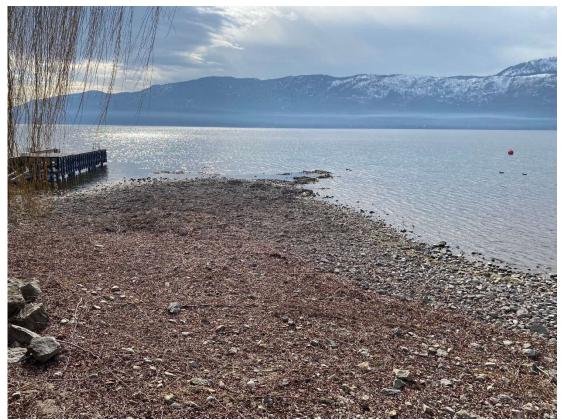
Photo 8:
Looking south
towards
Okanagan Lake
and the
bedrock that
extends into
the lake
towards the
southern
property
boundary
(March 5,
2021).
