## SITE PHOTOS

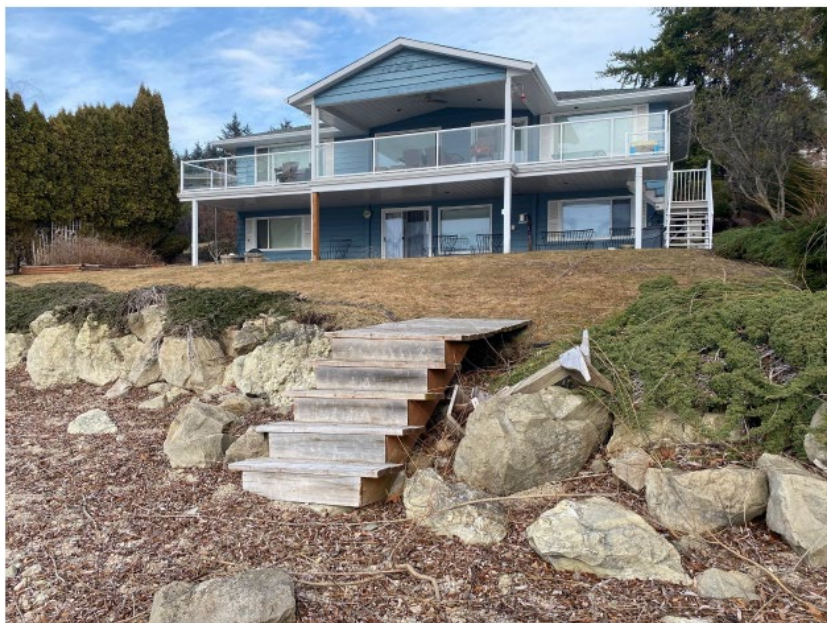
View at the subject property from the foreshore

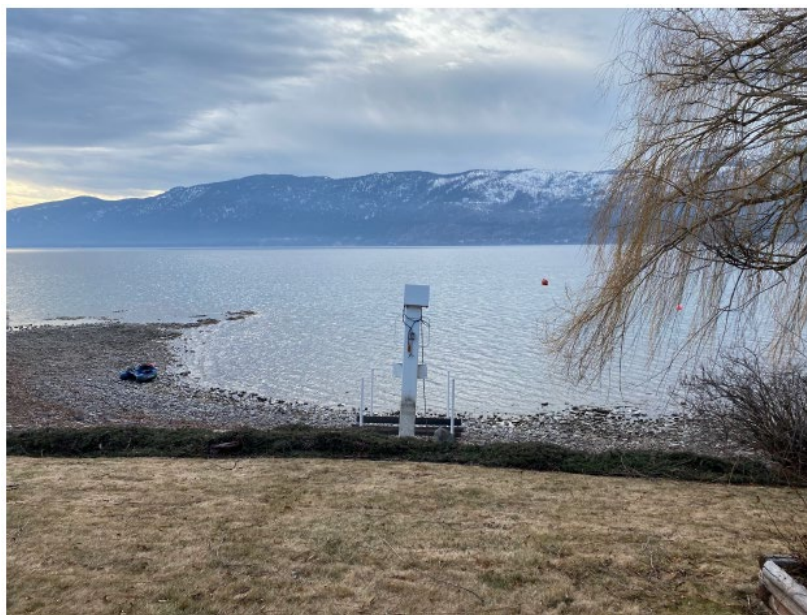
Southwest view – Boat lift remaining from the previous moorage

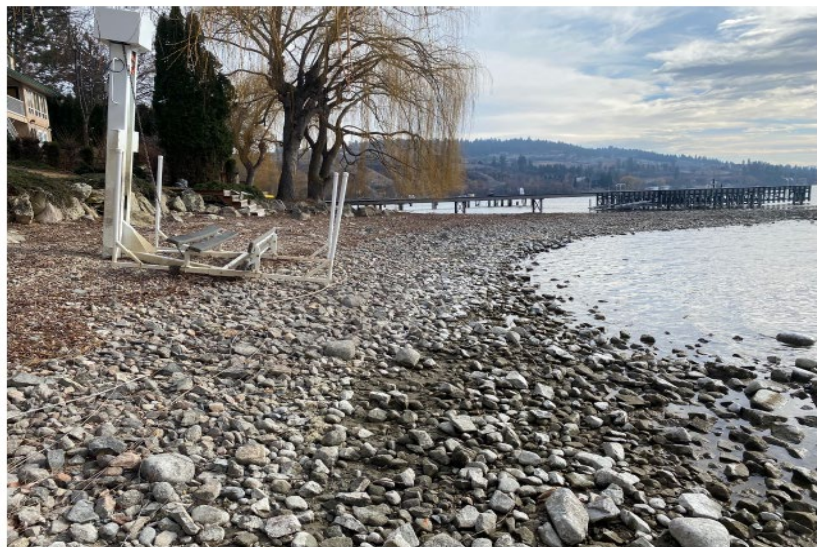
Southeast view -Gravel and cobble beach substrates

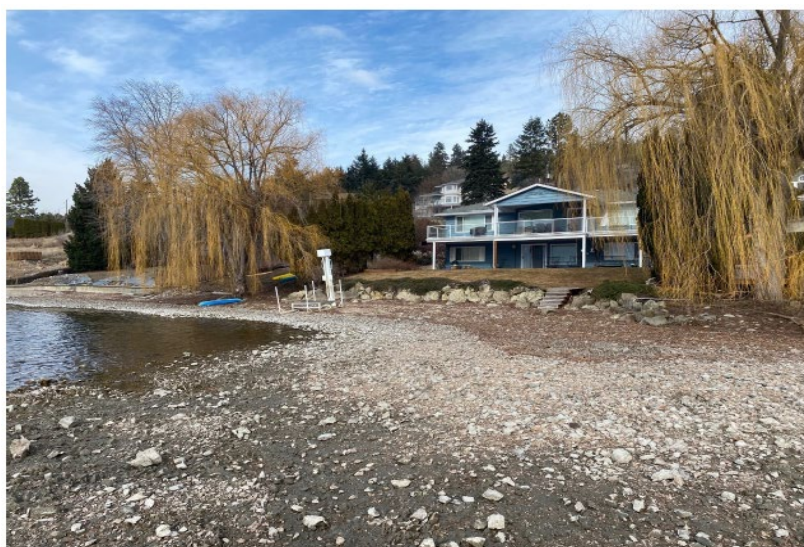
Northwest view along the foreshore to the boat lift-rock, riparian condition
